# Methods for Mitigating Growth of Laser-initiated Surface Damage on Fused Silica Optics at 351nm

*L.W. Hrubesh, M.A. Norton, W.A. Molander, E.E. Donohue, S.M. Maricle, B.M. Penetrante, R.M. Brusasco, W. Grundler, J.A. Butler, J.W. Carr, R.M. Hill, L.J. Summers, M.D. Feit, A. Rubenchik, M.H. Key, P.J. Wegner, A.K. Burnham, L.A. Hackel, and M.R. Kozlowski*

This article was submitted to the Boulder Symposium on Laser Optical Materials for High Power Lasers, Boulder, Colorado, October 1-3, 2001

Lawrence  
Livermore  
National  
Laboratory

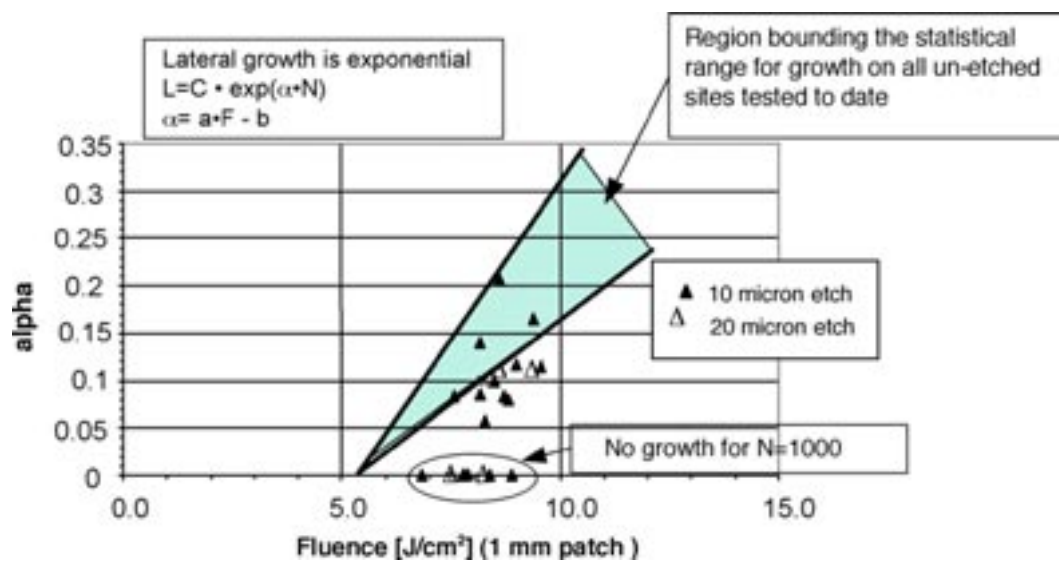
Figure 1. Plot showing results of damage growth experiments for wet chemical etched damage sites relative to the range of data for un-etched sites. About 40% of the etched sites did not grow for 1000 shots at the given fluences.

Our measurements show that damage sites that have been etched to depths greater than about 9  $\mu\text{m}$  have about a 40% chance for zero growth with 1000 shots at fluences of 6.8-9.4  $\text{J}/\text{cm}^2$  and  $\sim 1\text{ns}$ . For the etched sites that grow in this fluence range, the growth rates are consistent with those for un-etched sites. Contamination of the sample surfaces was observed for both the dipped and fountain etched cases, which could affect the variable results. Figure 1 shows the growth coefficient vs. fluence data for samples that were etched to depths of 10 $\mu\text{m}$  and 20 $\mu\text{m}$ , as they compare to the statistical range of data for un-etched damage sites. These results are encouraging for possible mitigation of surface damage. More data is needed for smaller damage sites to determine if the statistics for complete mitigation of growth improve for such sites.

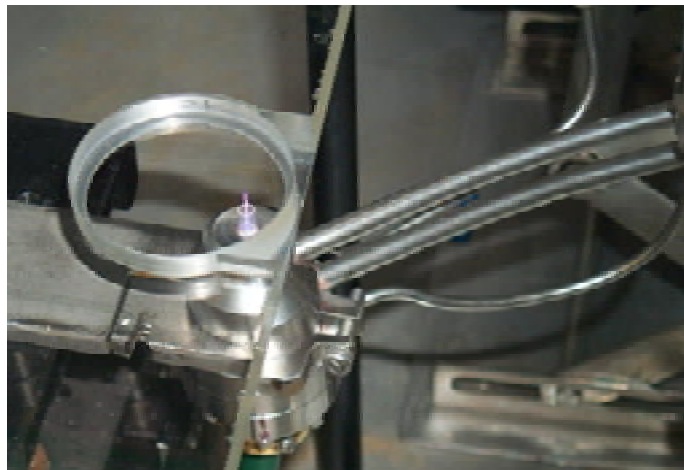
Figure 2. Photo of a RF micro-torch etching a local site on fused silica.

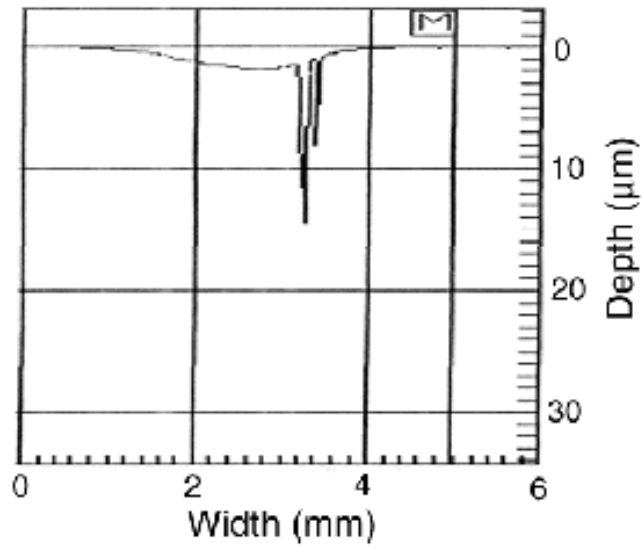
Figure 3. Profile of a 2 $\mu$ m deep pit micro-plasma etched over a 10-15 $\mu$ m deep laser-initiated damage site in fused silica.

The initial work with the micro-plasma torch exposed several problems; 1) the etch rate is very slow ( $\sim 2\mu\text{m}/\text{hr}$ ), 2) the etching does not rapidly smooth the damage pit, and 3) the plasma produces contamination residue in the treated area. Evidence for 2) is seen in the profile shown in Fig. 3, where the original damage pit has receded into the substrate without smoothing as the etching takes place. Apparently, etching by the micro-torch is not isotropic as is typically the case for chemical solution etching. The initial experiments to apply the micro-plasma torch to etch laser-damage sites resulted in the damage receding into the site rather than being smoothed. These sites were not tested for growth because there was not a significant change in the damage structure after etching.

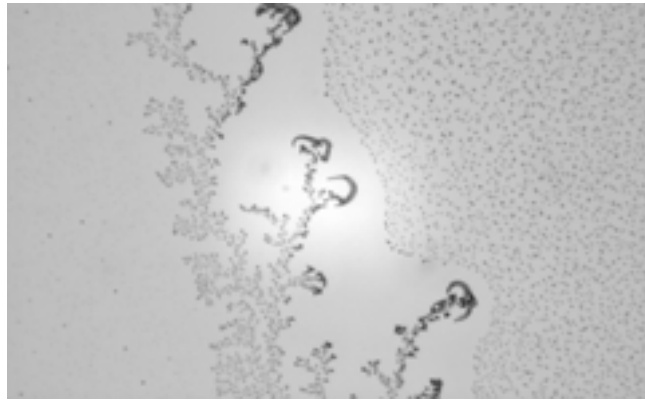
Figure 5. Photomicrograph of carbon containing deposits on the fused silica surface produced by decomposition of carbon-tetrafluoride gas from the plasma torch.

One sample was prepared for growth testing micro-plasma-produced pits on bare silica. All the pits were shallow ( $< 3\mu\text{m}$ ) due to low etch rates, and wide ( $\sim 1.8\text{mm}$ ). Microscopy of the pits before the tests disclosed some deposits located within each pit (see Fig.5). Analysis of the deposits showed that they contained carbon, which is believed to be residue from dissociation of the  $\text{CF}_4$  in the plasma. The laser fluence range for testing the growth at 351nm was  $6\text{-}8\text{J}/\text{cm}^2$ . All of the tested sites that had contamination developed a ‘stain’ within the first 20 shots, as they were illuminated at 351nm. These stains spread in the next 20-50 laser shots, to totally cover the original plasma-produced pit surface. The stains appeared to originate generally at or near visible contaminants within the pits.

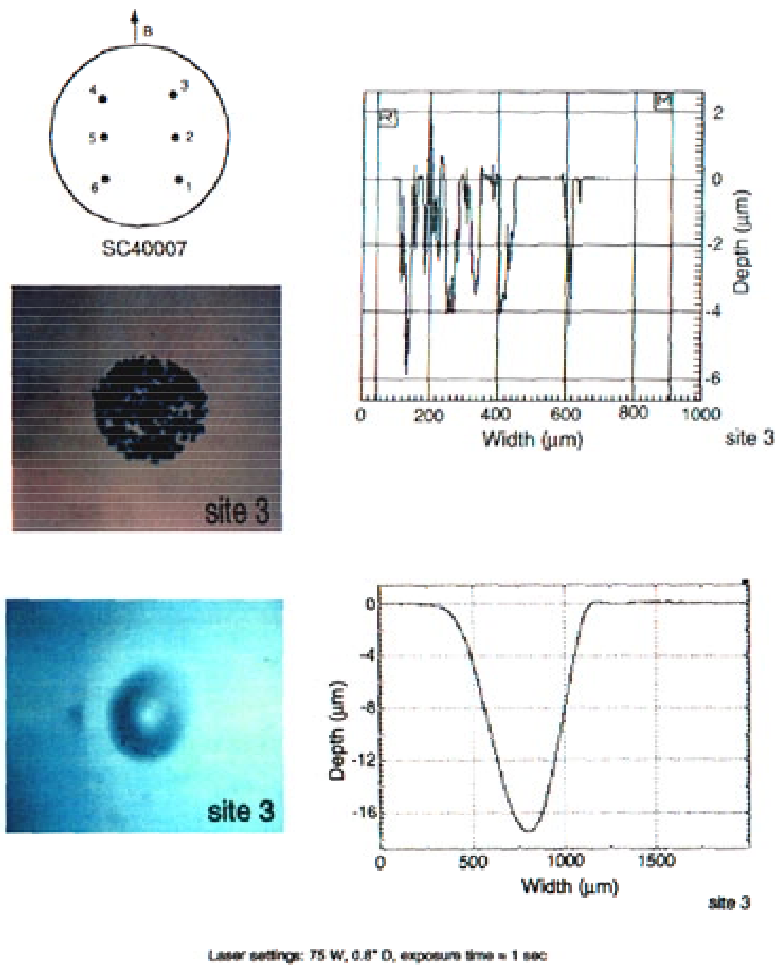
Figure 6. Example of surface damage mitigation by CO<sub>2</sub> laser processing. Many rough pits (top photo and graph) are transformed to a smooth Gaussian-shaped pit (bottom photo and graph) by a single 50W pulse in 1 second.

$\text{CO}_2$  lasers have been used successfully by others for reducing damage initiation on fused silica at 1054nm [7,8] but we were not aware of any attempts to use  $\text{CO}_2$  laser heating to treat existing damage on fused silica. We explored the use of  $\text{CO}_2$  lasers for mitigating 351nm laser-induced damage growth on fused silica. Preliminary experiments were done using an industrial size  $\text{CO}_2$  laser (Rofin-Sinar RS-1000, 1KW CW), primarily designed for cutting and welding. This laser was operated at reduced power ( $< 100\text{W}$  CW), with a focussed, Gaussian-shaped,  $1/e^2$  beam diameter of  $\sim 5\text{mm}$ , for one-second duration. The laser beam locally melted and evaporated the silica surface, typically producing smooth, Gaussian-shaped pits (see Fig.6). The pit depth ( $\sim 4\text{-}30\mu\text{m}$ ) depended on both laser power and de-focus.

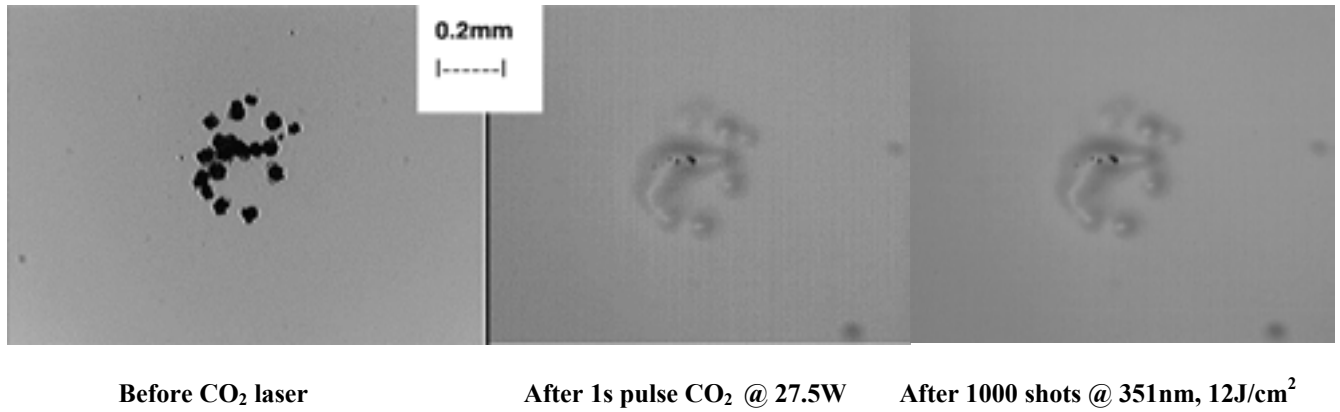
Figure 7. Optical micrographs of a laser-initiated damage site before (left) and after CO<sub>2</sub> processing (middle), and after exposure of 1000 shots at 351nm, 11ns (right), showing that damage growth is completely stopped.

The first damage tests at 351nm and  $\sim 11\text{ns}$  pulse width, showed that the  $\text{CO}_2$  laser-induced pits on undamaged silica, did not damage at fluences up to  $\sim 8\text{J}/\text{cm}^2$ . An extensive set of mitigation experiments was done for  $\text{CO}_2$  laser-treated, UV-laser-induced damage pits. Figure 6 shows examples of the UV-laser-induced damage and the pit produced after a one-second exposure of the  $\text{CO}_2$  laser at 50W. All of the  $\text{CO}_2$  laser-treated sites which were tested at 351nm,  $\sim 11\text{ns}$ , in the fluence range from  $\sim 6.7\text{-}12\text{J}/\text{cm}^2$ , survived 1000 shots. An example of the typical results for mitigating surface damage on fused silica is shown in Fig. 7.

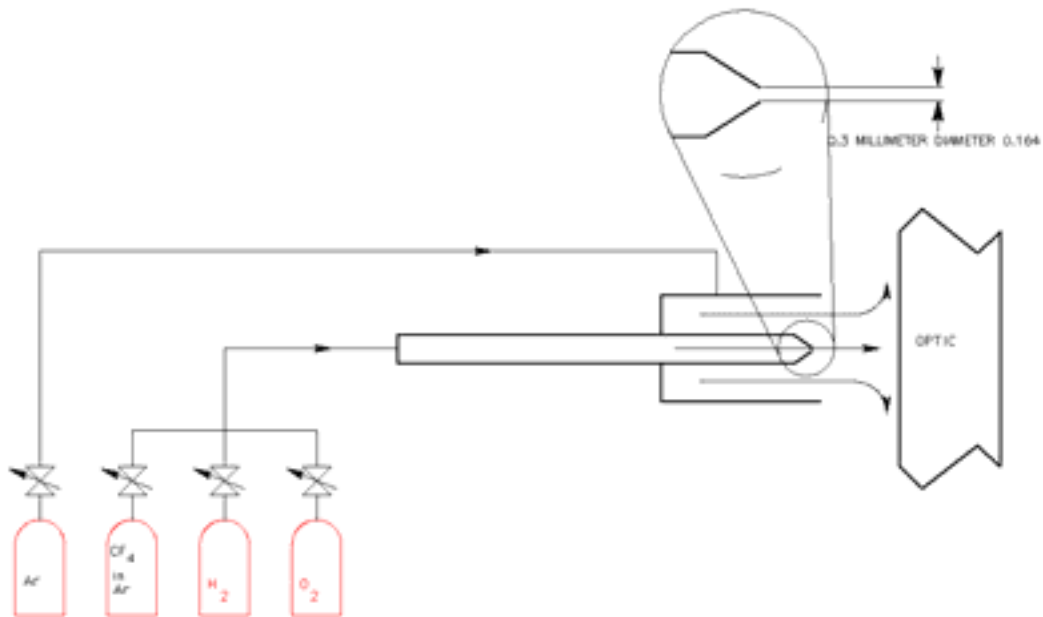
Figure 8. A schematic of the micro-flame torch system.

A hydrogen flame torch is another method to locally anneal a small damage site on fused silica. A miniature version of such a torch was developed and tested. The torch was fed by CF<sub>4</sub> to produce a hot flame with fluorine atoms that etch the silica surface. A schematic of the micro-flame torch system is shown in Fig.8. This torch represents an improvement over the RF plasma-torch for mitigation because it provides a combination of sufficient heat to soften the silica and fluorine atoms to etch the silica. It operates as an atomization source, wherein the hot flame dissociates the CF<sub>4</sub> molecules, producing F atoms, which attack the silica. The flame temperature can be varied to control the degree of dissociation. The torch produces a smooth, Gaussian shaped pit, approximately 1.5mm dia. and ~2 to 4μm deep, with no apparent lip. This torch was applied to treat 3 sites on a fused silica substrate.
